4. TITLE (and Subtitle) <b>National Program of Inspection of Non-Federal Dams Tennessee. Gladly Hollow Dam (OFDBA Site 41-1) near Lassiter Corner, Tennessee, Obion County, TN. Obion River Basin</b>		5. TYPE OF REPORT & PERIOD COVERED <b>Phase 1 Investigation Report</b>

PHASE I REPORT  
NATIONAL DAM SAFETY PROGRAM  
TENNESSEE

Name of Dam ..... OFDBA Site 41-1  
(Gladly Hollow)  
County ..... Obion  
Stream ..... Trib. of Hornbeak Creek  
Date of Inspection ..... February 4, 1981

PHASE I INSPECTION REPORT  
NATIONAL DAM SAFETY PROGRAM  
OFDBA GLADY HOLLOW SITE #41-1  
OBION COUNTY, TENNESSEE

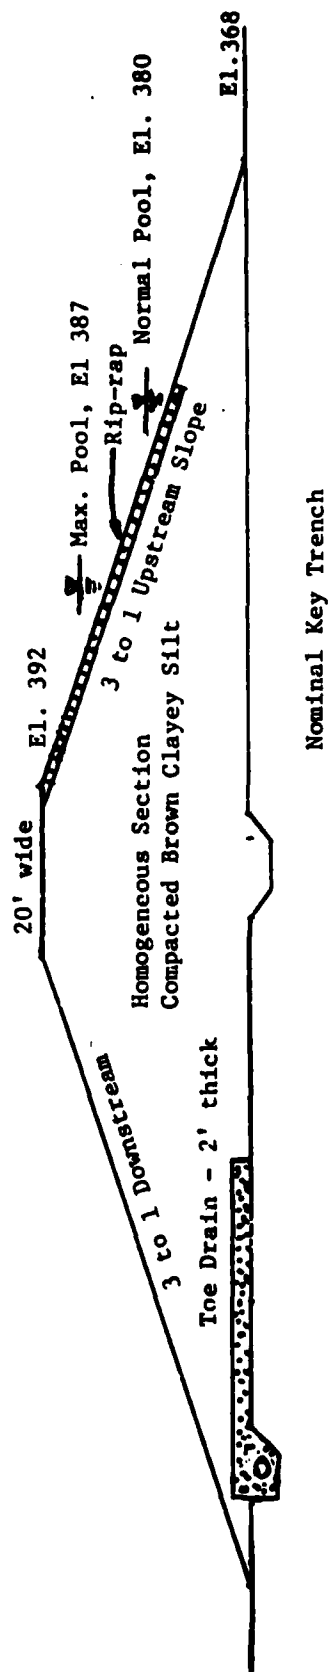
Figure 2. EMBANKMENT CROSS-SECTION.

A recommended embankment design cross-section is shown on the enclosed Figure 2. The test boring and the geologic data indicate that there is little likelihood of encountering a highly pervious layer within the valley bottom to a depth of 12 feet, and probably to many tens of feet more. Therefore, underseepage and sidesepage should not be a problem at this site. Available borrow materials from the spillway excavation will be the same clayey silt forming the entire soil profile. These soils can be easily compacted into a relatively impervious dam provided very close moisture and density control is maintained during construction. A modified-homogeneous cross-section is proposed, with a toe filter to provide positive protection against downstream toe piping.

A toe filter should be placed as shown on the attached drawing, Figure 2. Considering economics and availability of materials, it is recommended that a medium sand be used and a filter cloth be placed around the drain pipe rather than use a graded filter. Any sand gradation may be used provided it is free draining and contains no more than 1% passing the No. 100 screen. The toe drain should extend the full length of the dam, from water line to water line. The drain should have a width at least equal to that shown since its main function is to intercept underseepage and prevent erosion of the toe of the dam. Some seepage, of a lesser amount, is expected through the embankment of the dam itself. Compaction of the sand in place should be in accordance with the semi-compaction procedures as outlined in project specifications. The outer surface of the filter drain should be protected by a minimum by one foot of compacted earth fill to prevent erosion of the sand.
